## A BEACH MANAGEMENT MANUAL

Edited by Anton Micallef<sup>1</sup>, Sebastiano D'Amico<sup>2</sup> and Emanuele Colica<sup>1,2</sup>

**Produced by the University of Malta within the framework of Project BESS (*Pocket Beach Management & Remote Surveillance System*), funded by the Interreg Italia-Malta funding mechanism of the European Commission. The production of the methodological approach for beach management plan development and formulation of three case studies was carried out in collaboration with Adi Associates Environmental Consultants Ltd (Malta).**

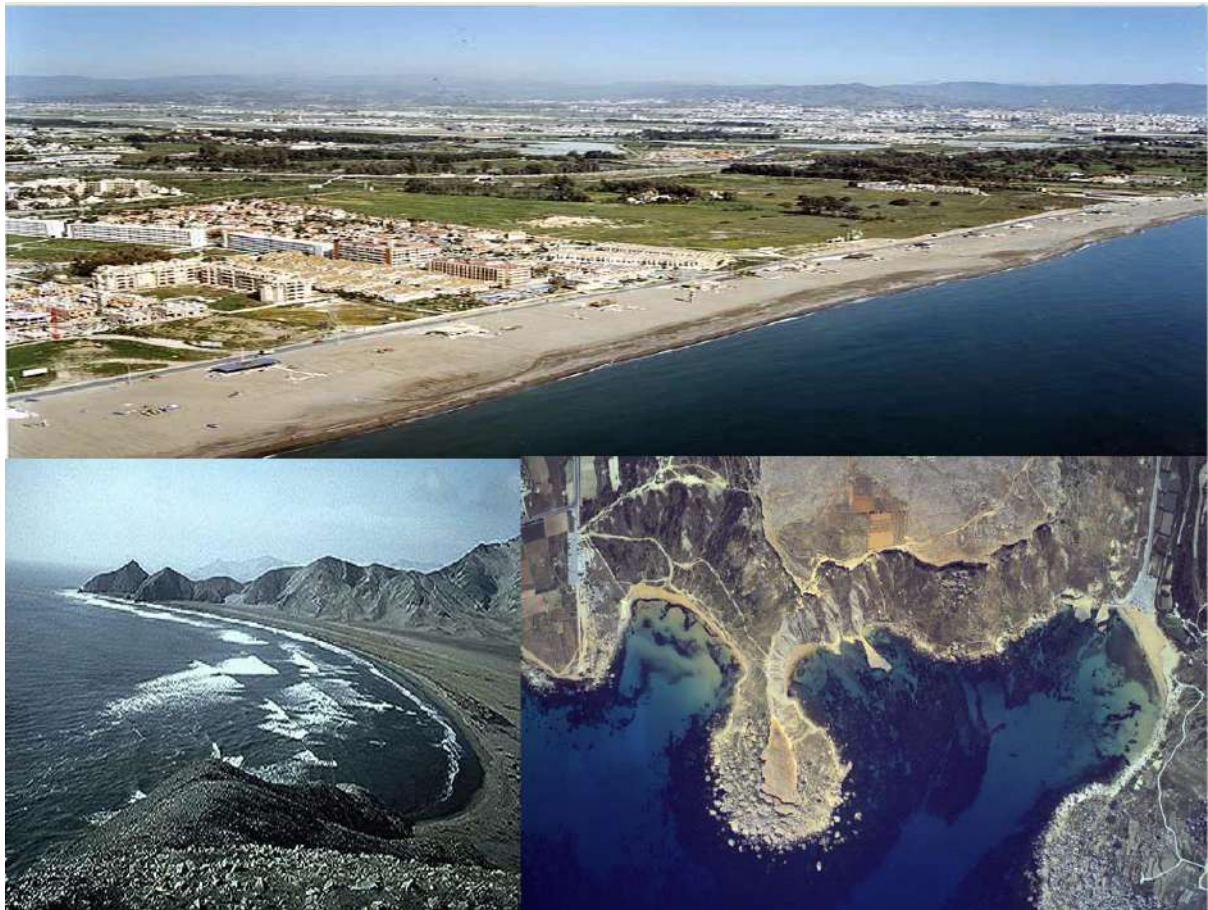
**Figure 2. A morphological classification of beaches, showing a linear beach (top), headland bound pocket beaches (bottom right) and a fish hook shaped beach (bottom left).**

Studies based on beach morphological characteristics have referred to two main types of beaches, namely those dominated by along-shore drift (producing *linear beaches* on open coasts), and swash dominated beaches typically represented by smaller *pocket beaches* that bounded by headlands (Williams & Micallef, 2009; Bird, 1996). Such pocket beaches are common to the Mediterranean, and typical of many beaches in Sicily and the only type found in the Maltese Islands. Davies (1980) further described a third beach-type which exhibits both swash and drift characteristics. The '*Zeta-form*' or fish-hook beach type is represented by only one headland which partially blocks long-shore sediment transport. This result in a swash dominated beach area in the lee of the headland, and drift dominated beach area down-drift of the headland (Figure 2).

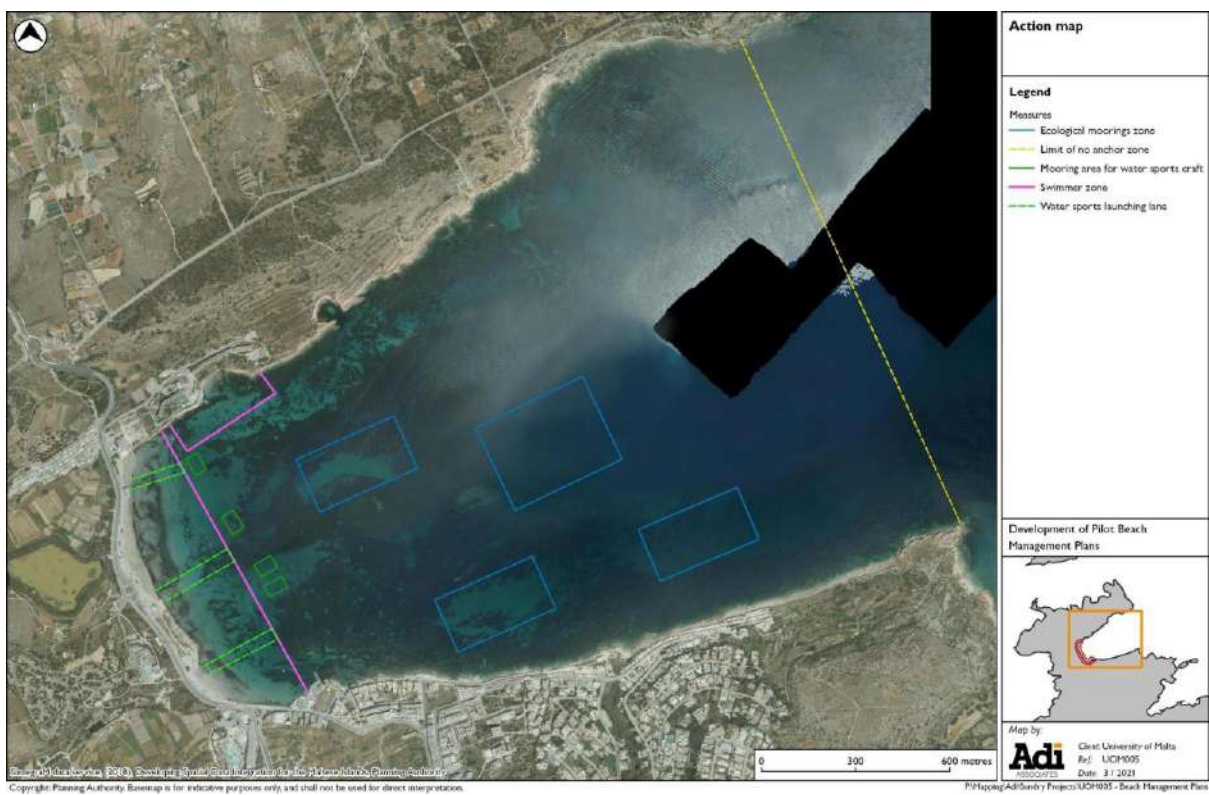
**Figure 6a: Actions Map for Ghadira beach (marine interventions)**

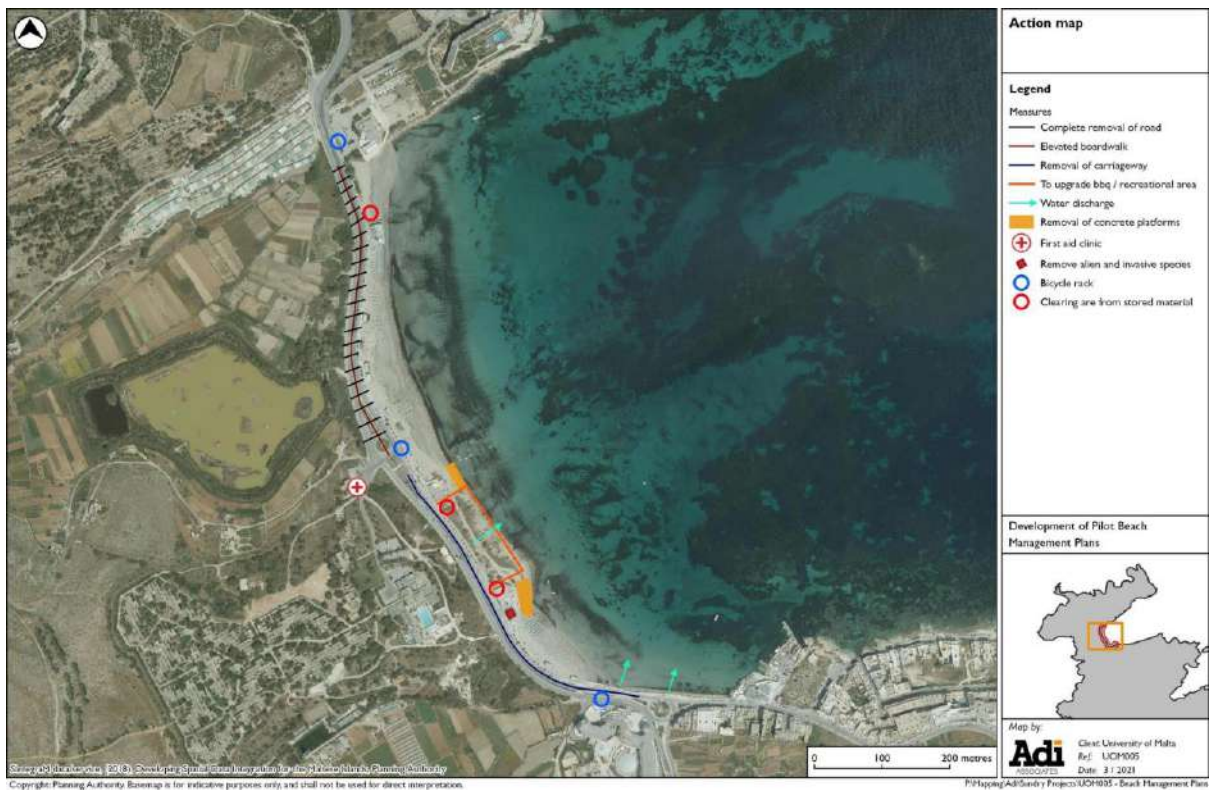
**Figure 6c: Actions Map for Ghadira beach (land intervention: if promenade and road are removed)**
